Aircraft Skin to Honeycomb Assemblies

Application Background

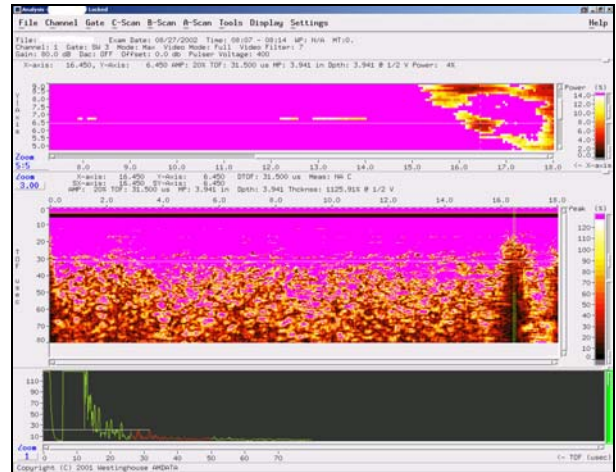
Unbond at Doubler Interface

The B-Scan slice shows 3 unbonds, the center of which is the minimum defect size required to be detected. In the B-Scan, the unbonds spread out as the depth of time increases.

A seemingly difficult flaw to detect is an unbond at the transition interface from a single skin to double skin (doubler). This defect however is easily detected with the Power C-Scan and supported via its B-Scan slice as shown above.

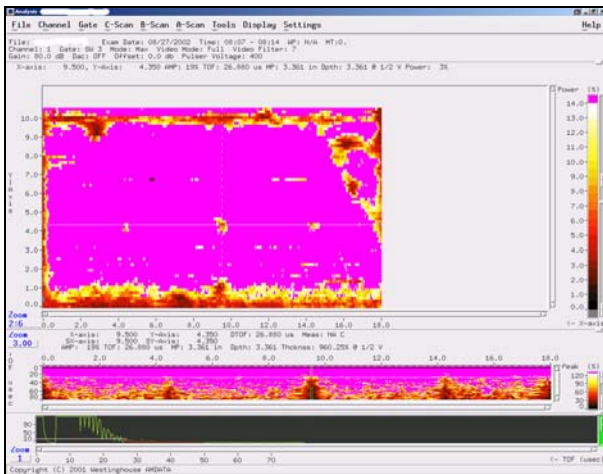
Overall Power C-Scan of Sample with Various Defects

A representative sample of a control surface was scanned. Relative to the image above, the leading (thick) end is on the top, and the trailing edge is on the bottom. A vertical structural member exists at the 10" X-axis location across the part. On the right side of the part, a double layer of skins exist, the beginning of which shows up as the diagonal line.

The top half of the above image is the C-Scan (plan view) of the sample. The image below the C-Scan is the B-Scan (side view). The bottom image is the A-Scan, which is the individual RF ultrasonic signal at the C-Scan's cursor.

A "Power" C-Scan view is used to analyze the acquired data. It represents the average energy of the C-gated signal and is very useful in detecting unbonds.

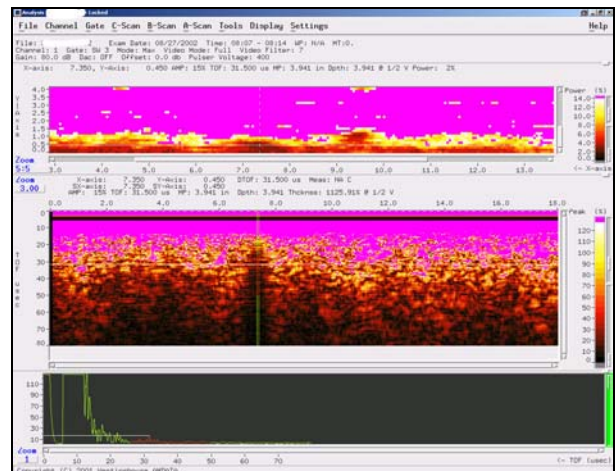
Trailing Edge Unbond

The most difficult defect to find with a single setup is at the trailing edge. Due to its thinness, bulk power levels are lower thereby narrowing the gap between good and unbonds. The image below, however, again detects and verifies an unbond adjacent to the trailing edge. Note that another unbond is located further inboard at the 9.5 position and is more easily detected.
